Oregon Humane Society

Baugh Construction Oregon, Inc.

The Project

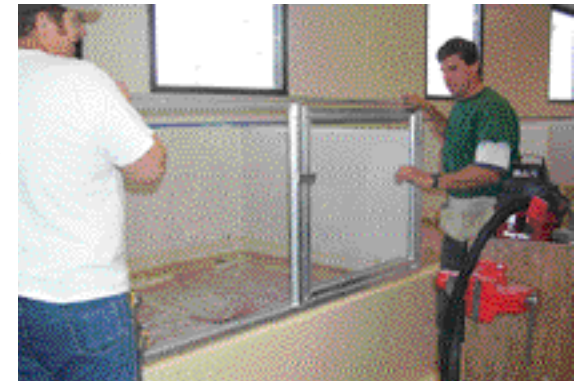
Installation of the puppy kennels. Notice the raised height of the kennels.

The puppy kennels were designed to be in the back of the kennel pod. Because the public can often be enthralled by puppies to the point of exclusion of adult animals, OHS and AMAA decided to place the puppies in the back. This way, the public views the adult dogs before seeing the puppies. Emphasis on the puppies is by no means minimized, and to ensure better viewing, the puppy kennels were raised off the floor. This allows the public to view more than the back of the dog without having to crouch down.

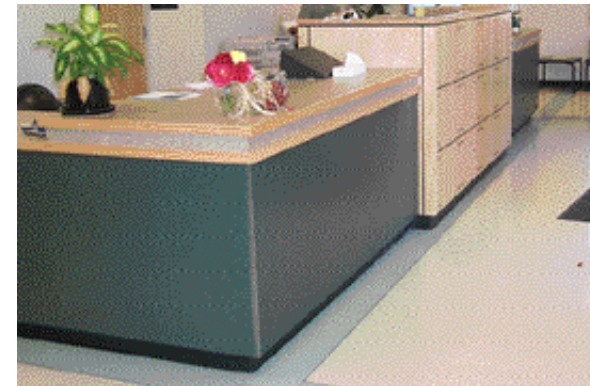
The animal receiving room. Notice the separate desks on either side of the central desk. The left side is used for dogs and the right side is used for cats. The door in the background leads to the isolation cages.

The animal receiving area was designed to accommodate a large number of both cats and dogs. Separate desks for the receiving of dogs and cats promotes a quieter atmosphere that results in less stress for the animals. The design team incorporated isolation cages connected to the receiving area and separate from the general population of animals, which allows animals to be held until they receive a health evaluation.

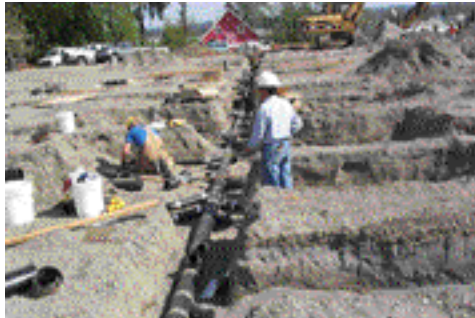
Six-inch drain pipes underneath the kennels

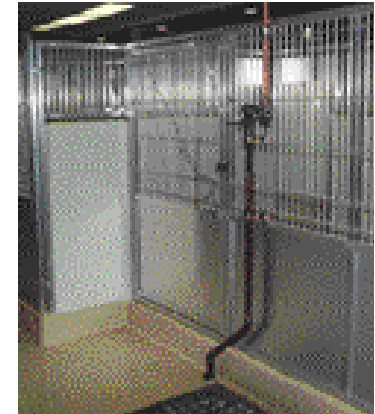
flush drains in the kennels

For cleaning and waste management, flushable floor drains were installed. Each kennel is served by a separate drain. These drains have acid resistant enamel floor grates that separate solids. Double screens in the drains filter out large objects and help keep the pipes from clogging. Wash down systems have retractable hoses for easy storage and include special chemical insertion for sanitizing and cleaning the area.

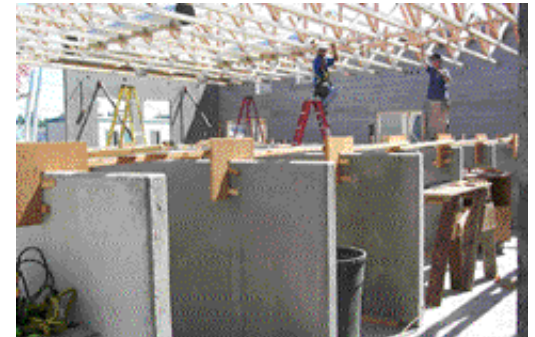
Construction of the kennels. The pre-cast panels separating each kennel can be seen in the foreground.

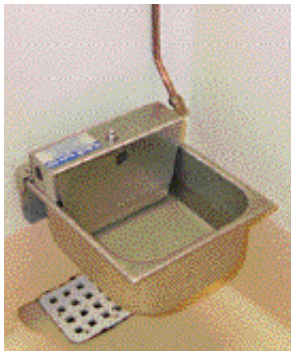
The automatic watering system.
Photo by: Kelly Ballance

An automatic dog watering system was included to provide a constant supply of fresh drinking water to each kennel. To create the system, Southland Industries contacted Nelson Manufacturing Company, a company that specializes in livestock and animal automated watering systems. Southland ran a one inch main water supply along the top of the kennel walls from the potable water supply, after installing a backflow preventor, to protect the main water supply from contamination. Having separate bowls in each kennel allows each bowl to be isolated for individual cleaning and servicing tasks. The bowls are made of stainless steel, with a float that adds water as it is used. The bowls are held in place with a stainless steel bracket, with a locking stainless steel slide for easy removal and disinfection between occupants.

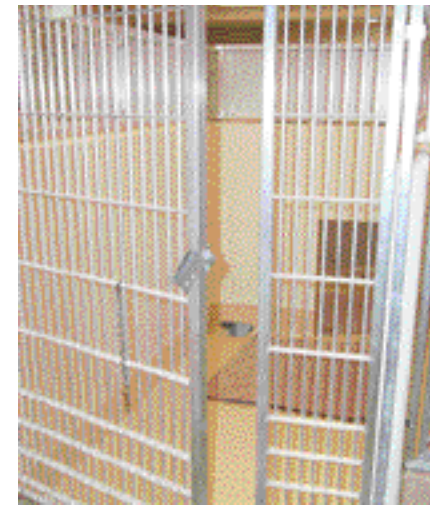
LGL Kennel gates. In the background, the opening between the night cages and the day cages can be seen. HDPE gates were used to separate the two cages.

LGL aluminum cages complete the main kennel structure. High Density Poly-ethylene (HDPE) separation gates were used in the kennels instead of aluminum or steel to minimize potential injuries to the animals. These gates separate the staff side of the kennel from the public side. HDPE gates, while strong and durable, are much lighter than aluminum or steel, so if the gate were accidentally released while the animal is underneath, the injury would be minimal. Other benefits of choosing the HDPE gates are that they are less expensive and easier to replace. While aluminum and steel gates must be fabricated in a shop, the HDPE gate can be cut to size on site.

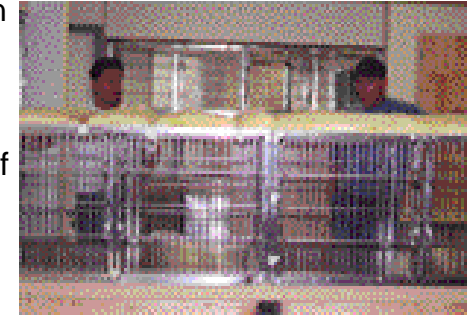
Installation of the double-sided cages in the cattery. These allow for ease of access by the staff and for maximum ventilation benefits.

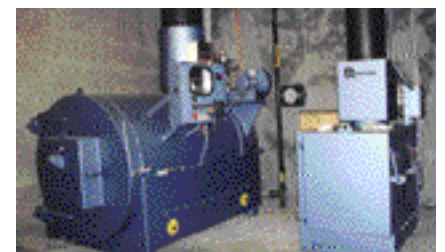
Thermtec incinerators. The one on the left is used for general cremations. The one on the right is used for private cremations.

There are two incinerators in the building. The larger incinerator used for general cremations is a Thermtec model G-16-P. The smaller incinerator, used for private cremations, is a Thermtec model S-18.

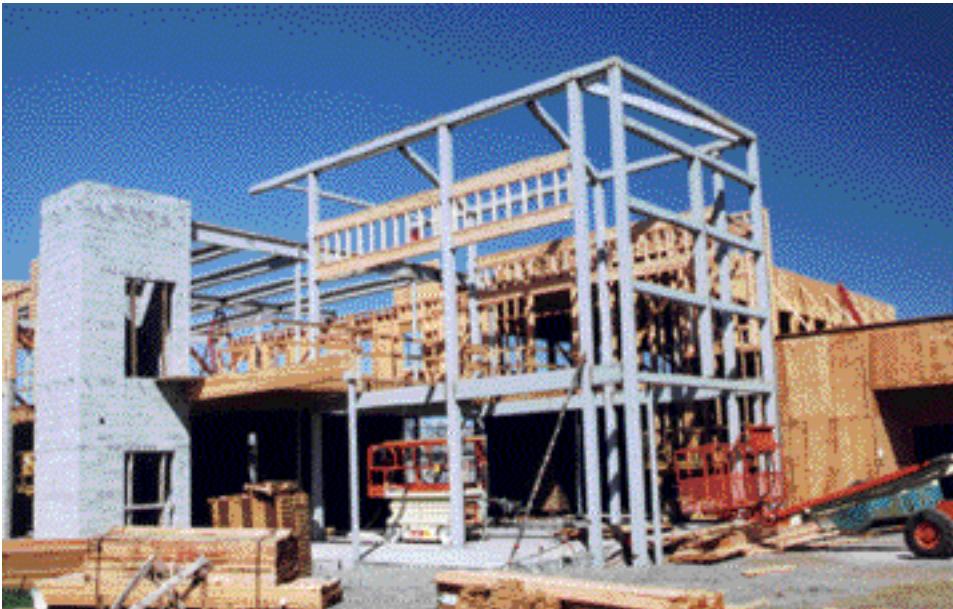
Concrete block, metal, and wood structure of the building front

One of the main points of interest in the construction of this building is that a variety of materials was used. This one building incorporates concrete blocks, concrete tilt-ups, wood structure systems and steel structure systems into a unified structure that meets the Humane Society's needs and is aesthetically pleasing to the eye. This complex composition did not come without its challenges. One of the structural challenges the team faced was working out the connections between the metal stud and the wood stud systems.

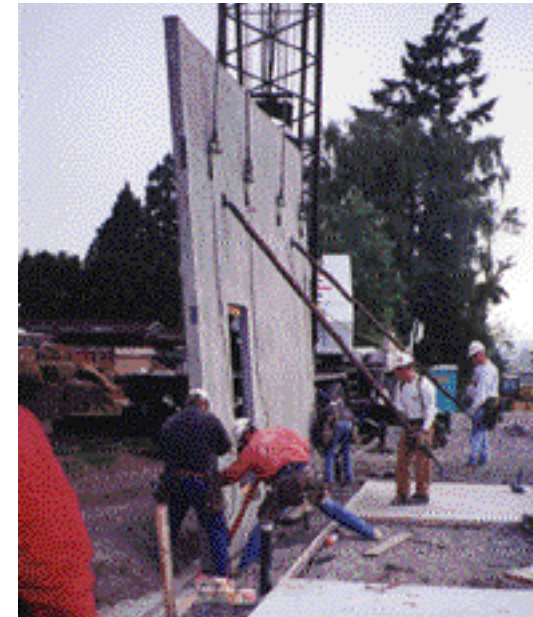
Concrete tilt-up walls used in the kennel area
